LAKEVILLE ARENAS BOARD MEETING

September 20, 2023

HASSE PAVILION RINK CONSTRUCTION

Project: 21986 Lakeville Hasse Arena Report Number: n/a
Outdoor Rink Expansion (BP #2) From: Kurt Schoenecker, APEX
 To: Joseph Bergquist, Arena Manager Date Observed: August 22, 2023
Lakeville Arenas Project Number: 21986
 Re: Exterior perimeter concrete slab Contract For: _____

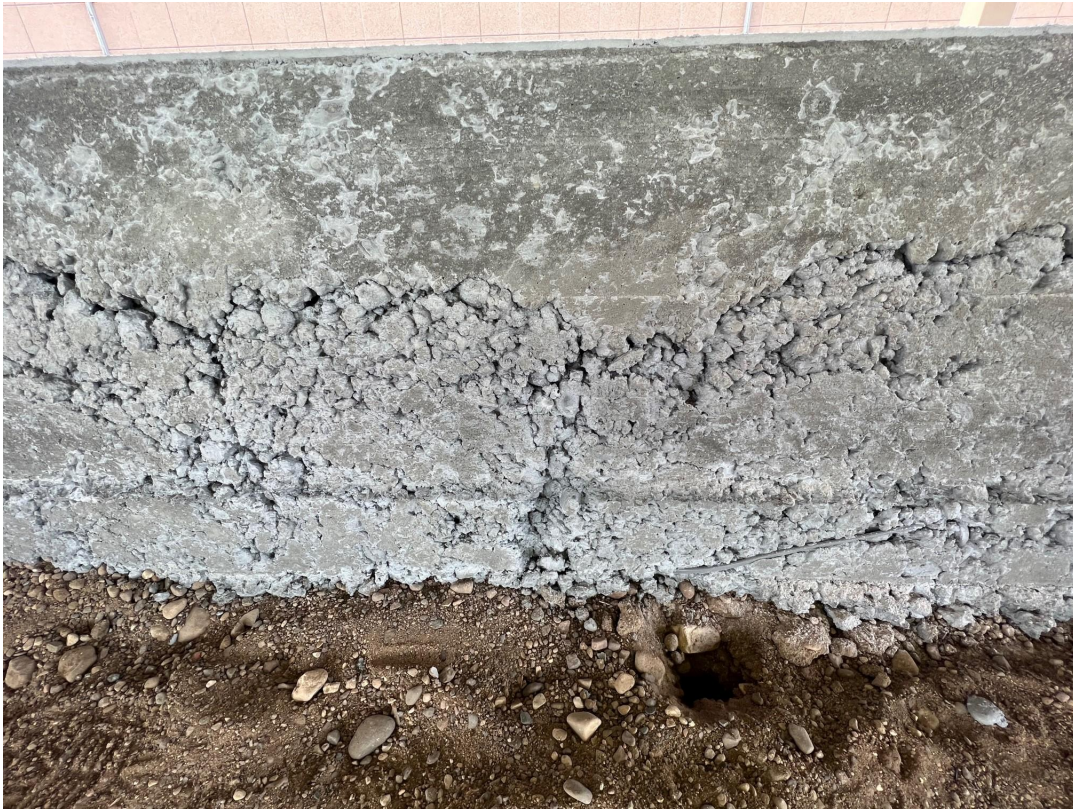
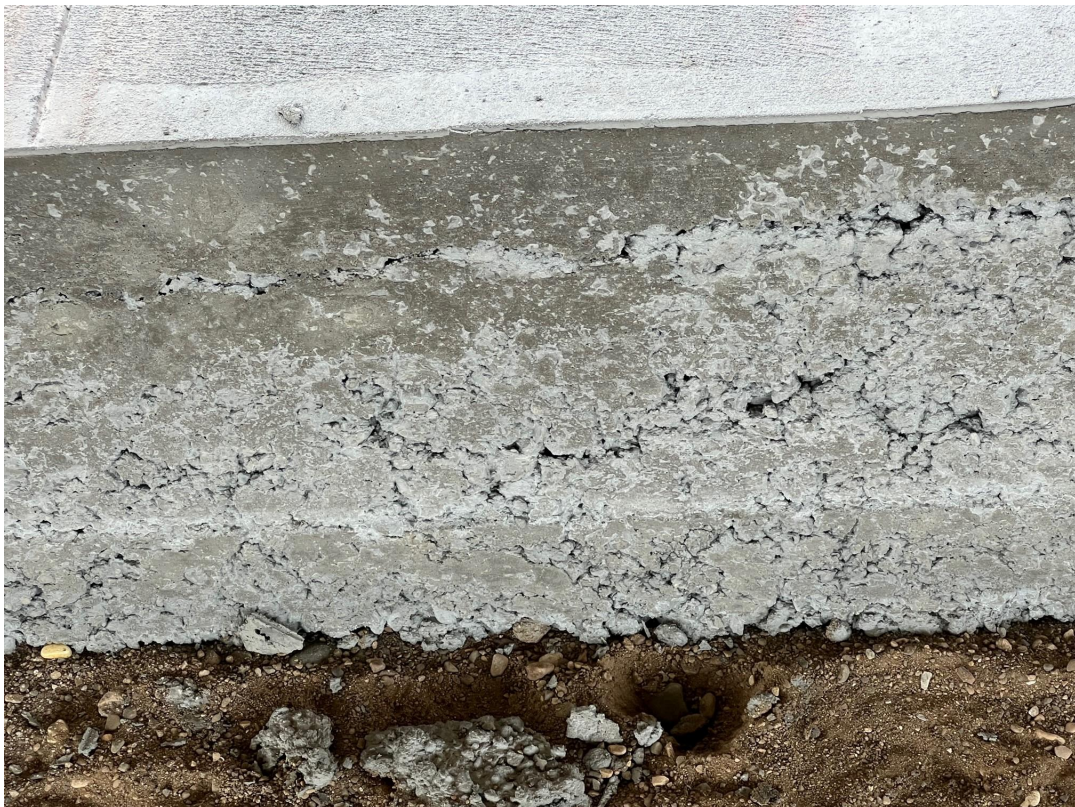
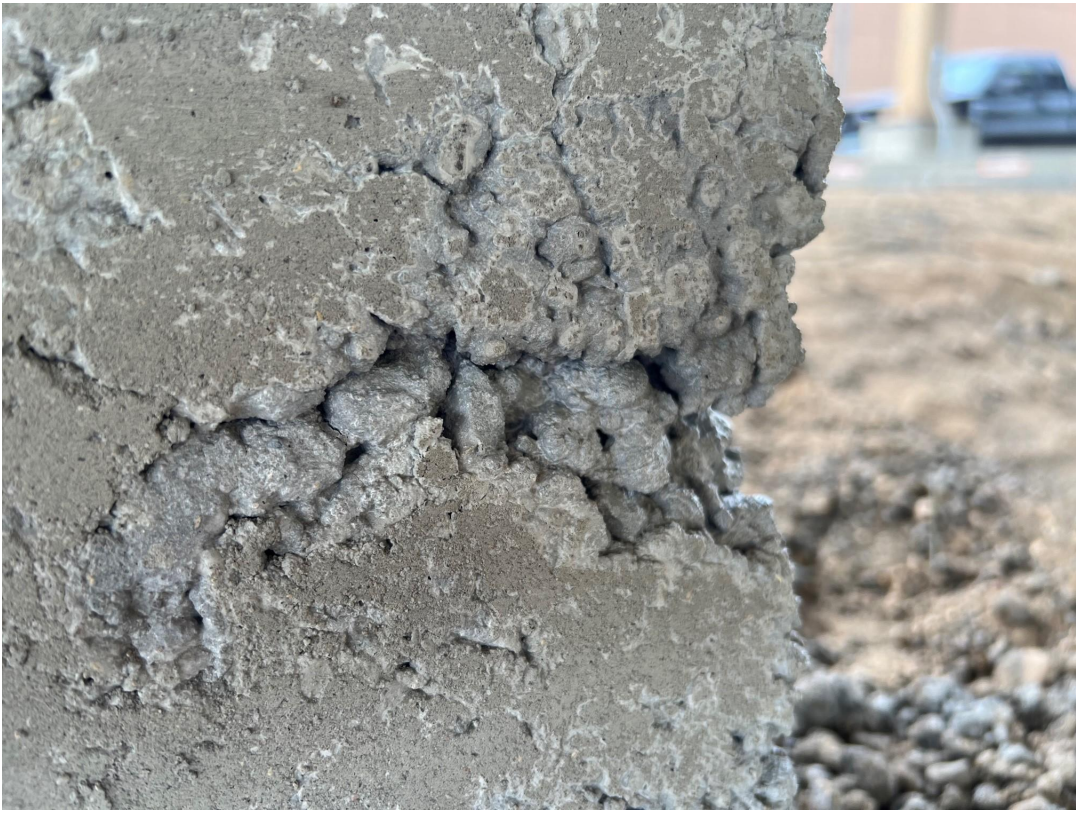
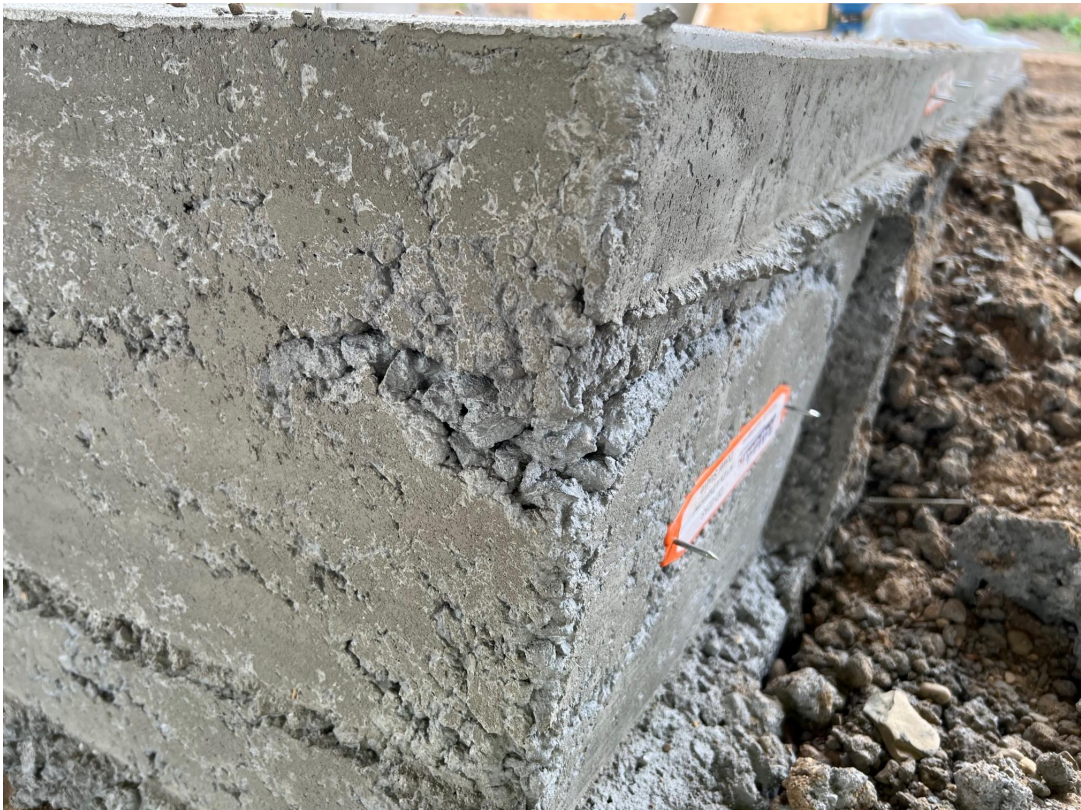
As observed in photos and a site reports by the Engineer of Record (Eric Nelson, Nelson Rudie) and special testing agency (Christopher Kehl, Braun Intertec), the thickened slab edge is visibly honeycombed around the entire perimeter. The consensus was the thickened slab edge was not vibrated, and two (2) concrete pours of varying stiffness created the honeycombing and cold joint as shown in the photos. Reference standard ACI 304R notes vibrating during the pour as best practice for formwork along vertical surfaces.

The current state of the thickened slab edge creates the following performance issues: honeycombed concrete will limit the holding power of the powder actuated fasteners, the exterior slab is subject to moisture intrusion into the slab with potential for freeze-thaw damage (spalling).

Thickened concrete slab edge. Image courtesy of APEX (08.23.2023)

Arena management agrees with the architects and would like Sheehy to remove and replace the slab. We are expecting a fight but believe removal and replacement is the correct decision to ensure the longevity and integrity of both slabs. Management is asking for a motion by the board to reject the proposed patch repairs to the perimeter slab and instruct Sheehy Construction to remove it and replace it with a new slab that conforms to the intended specifications, at no additional cost to the city.

As observed in photos sent prior to the site visit, the slab edge was visibly honeycombed to varying degrees around the full perimeter. The slab edge was admittedly not vibrated during the pour as noted in ACI 304R as best practice for formwork along vertical surfaces. There were also a few areas noted that appeared to bulge inward where a portion of the edge form moved during the pour.

The main concern for honeycombed concrete in an exterior face condition is freeze/thaw expansion causing the concrete edges to spall or crack in a continuing repetitive process. The contractor has submitted a patch mix to fill the voids along the edges to rectify these concerns. If properly applied, we feel this will be an acceptable repair. The repair will also require grinding all concrete bulging toward the rink slab to produce a smooth, vertical surface around the full perimeter.

The client is paying for a perimeter rink slab constructed free of unreasonable defects that should last for many years. This slab could be rejected by the architect but we believe a more practical solution at this time would be to patch and seal the void areas. A repaired slab edge has higher potential of breaking down and allowing water into void spaces where it can spall and crack due to freeze/thaw conditions. The owner needs to be aware of this concern and the contractor needs to make an agreement with the owner to be responsible for damage to the slab caused from this breakdown for a reasonable time period, or at least until perimeter walls are erected to enclose the structure. If the contractor does not agree to be responsible for these repairs as noted, I recommend rejecting the slab and having it replaced.

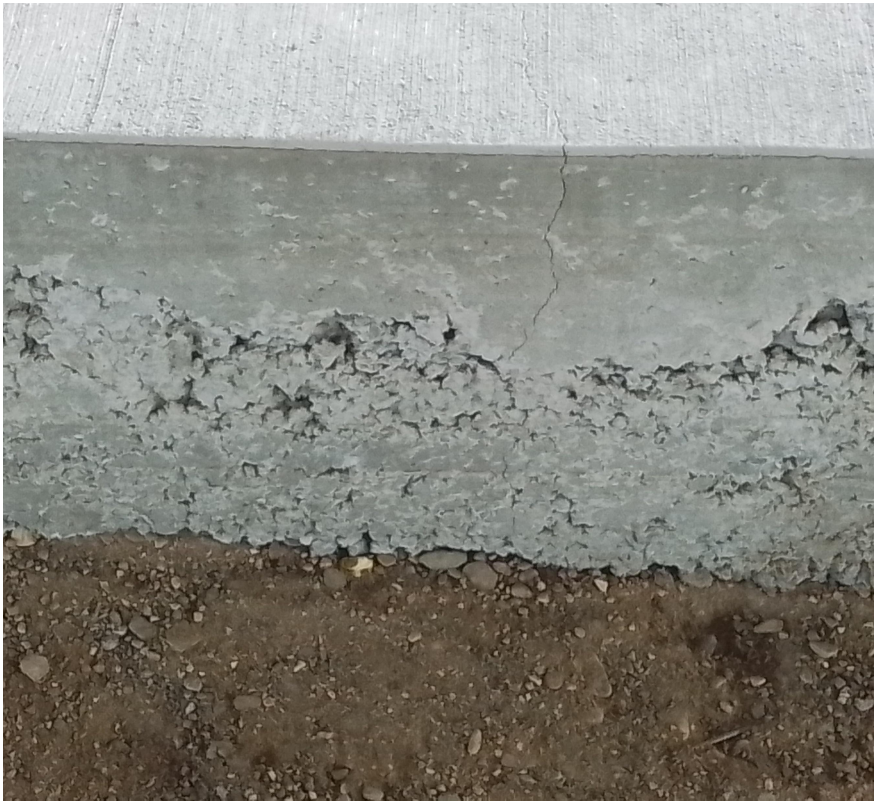
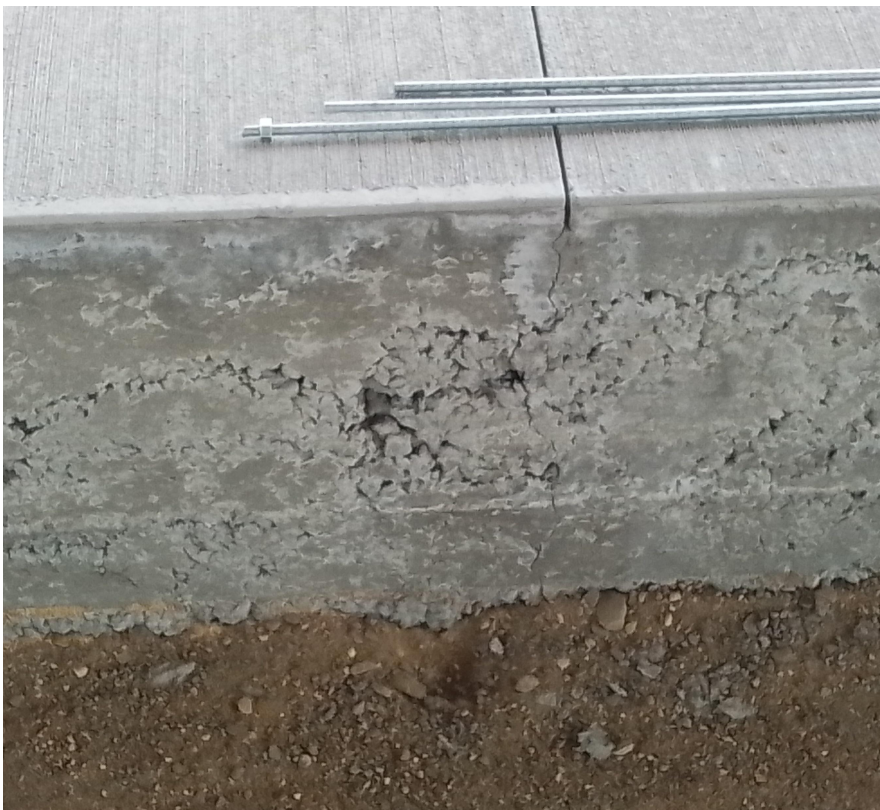
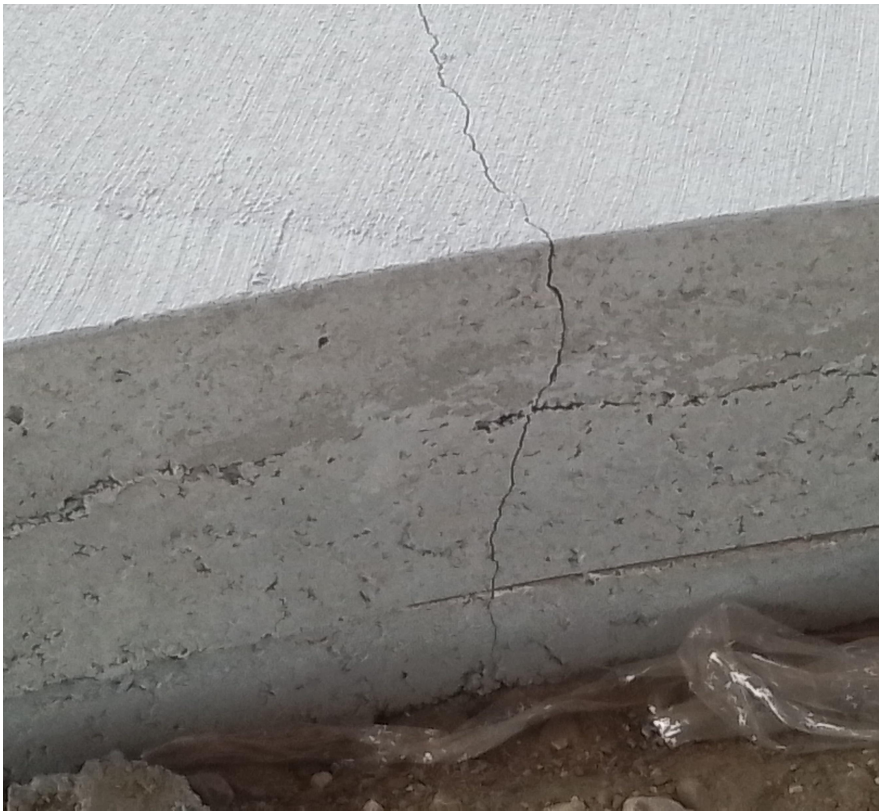
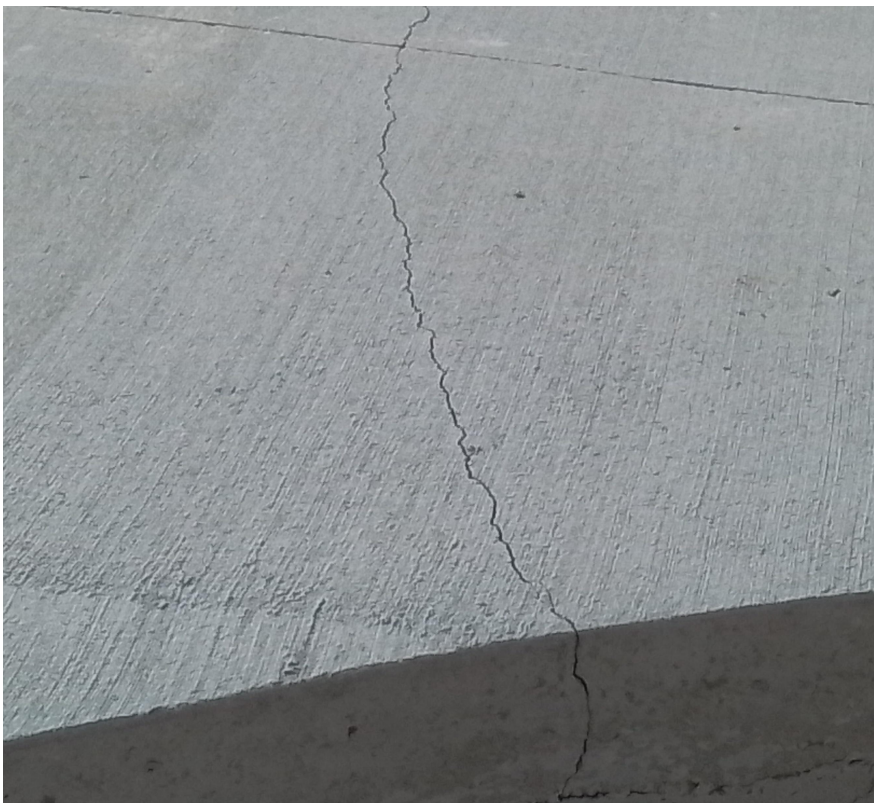
After further review of the perimeter concrete slab, Nelson-Rudie has updated their response letter dated September 18, 2023. Additional photos of concrete cracking is included for reference.

Concrete slab cracking. Image courtesy of APEX (09.08.23)

Another concern that was pointed out on my arrival was unusual cracking of the slab at nearly every pier. It's not unusual for concrete to crack at projections through slabs but there's a control joint centered on every

pier. The cracks only follow control joints in 2 locations, the remainder begin at pier corners and extend through the slab edge.

A slab control joint is intended to create a weak plane in the slab to attempt to force cracks in clean, straight lines. When concrete shrinks during the curing process, tension builds up in the slab and it will split at its weakest vertical plane. This slab is reinforced with #3's @ 12" o.c. Note #1 on detail 1/S300 states that every other reinforcing bar below slab joints are to be cut. Cutting every other bar ensures that the steel reinforcing only has half of the typical tensile strength below the joint. Cutting the concrete surface directly over the weakest steel location forces the crack into the joint. If this were followed, most or all cracking at piers should've occurred in the control joints. There's never a guarantee that cracks will follow control joints as intended but most will if a proper weak plane is created. Cracks and joints are maintenance items that need to be sealed with a flexible sealant to prevent water from entering the slab.

Summary recommendation to Owner for review and approval:
 Given the non-adherence to the specifications, condition of the slab edge and additional long-term maintenance requirements to the Owner, it is our professional opinion and recommendation to replace the slab.

According to specification section 3.09, this slab qualifies as "Defective Concrete". Given the nonadherence to the specifications, condition of the slab edge and additional long-term maintenance requirements to the Owner, it is our professional opinion and recommendation to replace the slab.
