ISLAND LAKE – EAST

3555 NORTH VICTORIA STREET
SHOREVIEW, MN

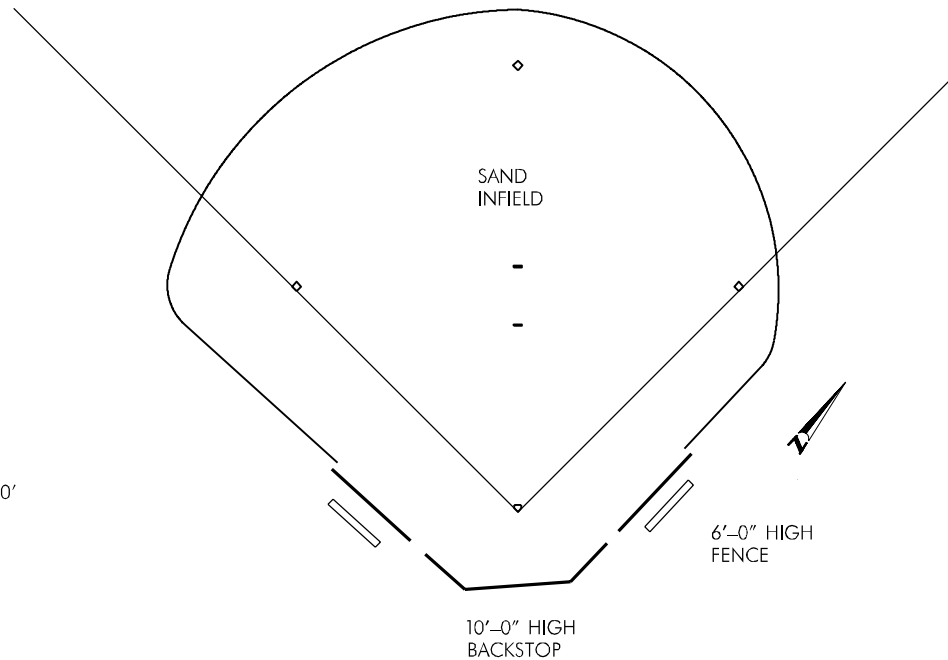
SAND INFIELD
60' BASE PATHS W/O BASE ANCHORS
1ST PITCHING RUBBER 35' FROM HOME
2ND PITCHING RUBBER 46' FROM HOME
NO HOME RUN FENCES
NO OUTFIELD OBSTRUCTIONS FOR OVER 300'

BASES NOT SECURED TO FIELD
10'-0" HIGH BACKSTOP
13'-10" FROM HOME PLATE TO BACKSTOP
15'-4" FOUL TERRITORY ON 1ST BASE SIDE
19'-0" FOUL TERRITORY ON 3RD BASE SIDE

FIELD IN VERY GOOD SHAPE
FENCES ARE IN GOOD SHAPE
